**Incident of a 275-kV Fault in HK Electric's Power System  
on 19 April 2023**

**INCIDENT INVESTIGATION REPORT**

Date: 15 May 2023

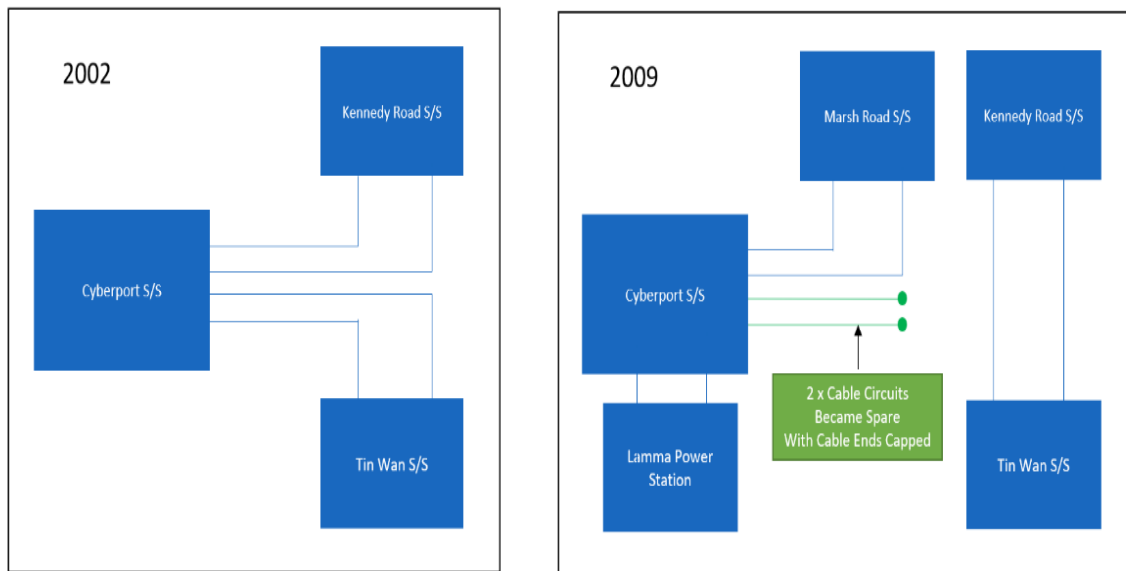
Illustration 1. Network Change at CPX in 2002 and 2009

- 2.1.3 Following the installation and commissioning of the two Lamma Power Station to Cyberport 275-kV submarine cable circuits in 2006, the two 275-kV cable circuits which were used to supply CPX in 2002 were restored to their original configuration. Two of the four CPX cable circuits were then extended and connected to Marsh Road 275-kV Switching Station in Wanchai in 2009 for delivering power to the northern part of Hong Kong Island while the remaining two have since become spare cable circuits. One end of these two spare cable circuits was capped inside Kai Lung Wan cable tunnel portal while the other end remained connected to the 275-kV switchgear of CPX.

- 2.1.4 As these two spare cable circuits were laid in a common trench with the other two extension cable circuits to Marsh Road 275-kV Switching Station, they were designed to be reserved for future use such as possible emergency repair of the extension cable circuits as well as for possible future network reinforcement/expansion. While these spare cable circuits were connected to CPX, considerable amount of works including cable jointing and testing would be required before they could be put into service. The two cable isolators at CPX connecting to these two spare cable circuits were opened and locked by unique lock to ensure these spare cable circuits were securely separated from our in-service transmission network. Details of the network change mentioned in 2.1.3 and 2.1.4 are shown in Illustration 1.

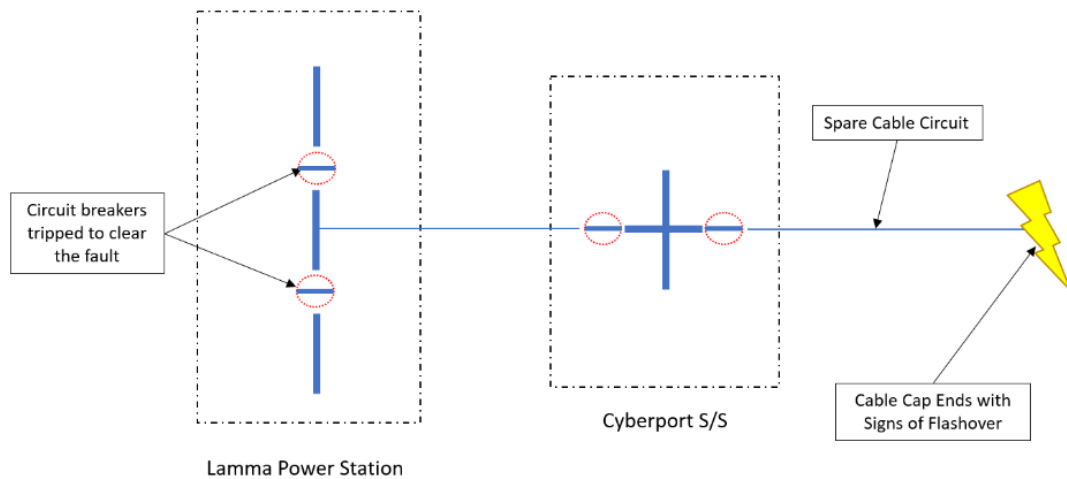
Illustration 2. Network Arrangement at the Time of Commissioning

The engineer in charge was the authorised person responsible for the whole commissioning work at CPX according to the approved procedures. Another engineer with appropriate qualification was also deployed to CPX to double check the GIS gas pressure and to carry out specific parts of the commissioning procedures not related to circuit energisation. The whole process was also supported remotely by an engineer in the System Control Centre at Ap Lei Chau, who was responsible for switching on and off the GIS during commissioning according to the site condition as confirmed by the engineer in charge as well as the approved commissioning procedures using remote control facility. At 00:45 hours on 19 April 2023, as per confirmation of the engineer in charge, the engineer at System Control Centre energised the cable isolator whereby a 275-kV three-phase fault occurred and relevant Circuit Breakers (CBs) of the dedicated commissioning circuit tripped correctly by backup protection system to isolate the fault. The simplified network arrangement at the time of commissioning is shown in Illustration 2 below. Subsequent investigation concluded that the spare cable circuit connecting to cable isolator L53A was inadvertently energised. The spare cable circuit is an oil-filled cable. One end of the cable is connected to the GIS while the other end is capped to contain the insulation oil. Flashover occurred at the cable cap-ends immediately when a high voltage, i.e. 275 kV, was applied. The cable cap-ends are used to contain the insulation oil of the spare cable circuit and are not designed to withstand any high voltage. The fault was then isolated by the protection system as designed within half a second.

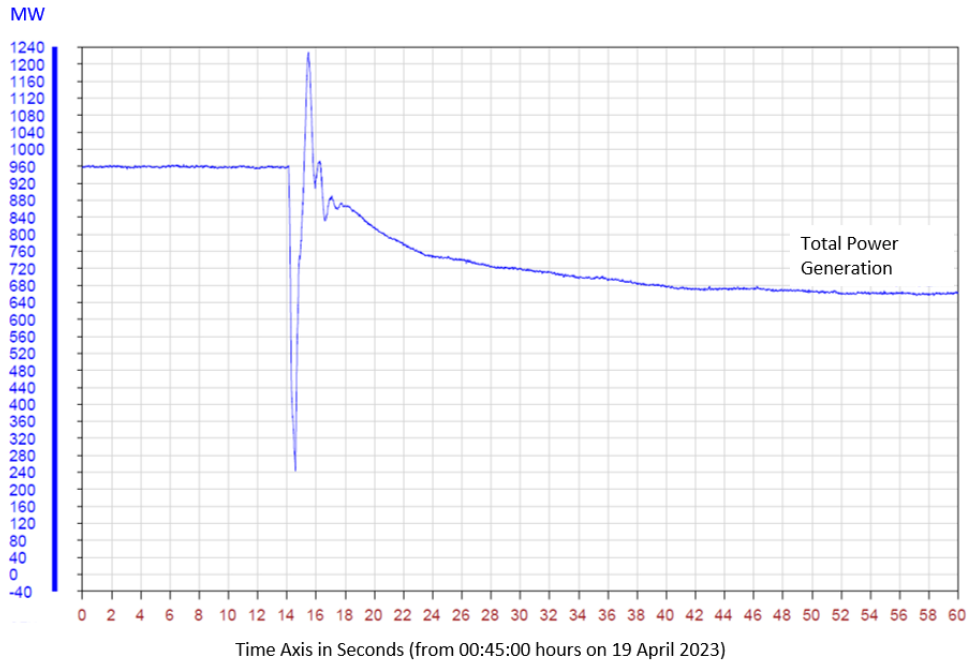
Illustration 3. Total Power Generation of Lamma Power Station on 19 April 2023 at 00:45 Hours

All the generating units at Lamma Power Station and their auxiliary equipment were also seriously affected by this unprecedented power disturbance. The total power generation in Lamma Power Station fluctuated seriously in the first few seconds after the occurrence of the fault (refer to Illustration 3 below). The protection systems of the auxiliary and major equipment functioned to protect them from damage. For example, the lubricating oil pumps of some coal mills affected by the voltage dip were tripped by the undervoltage protection such that the cables and the motors of the pumps had been protected from overheating; and the moving parts of the coal mills had been protected from excessive wear by tripping the mills when the pressure of the lubricating oil dropped. These protection systems were designed for preventing damage of generating units during severe power disturbance rather than allowing them to ride through a system fault.

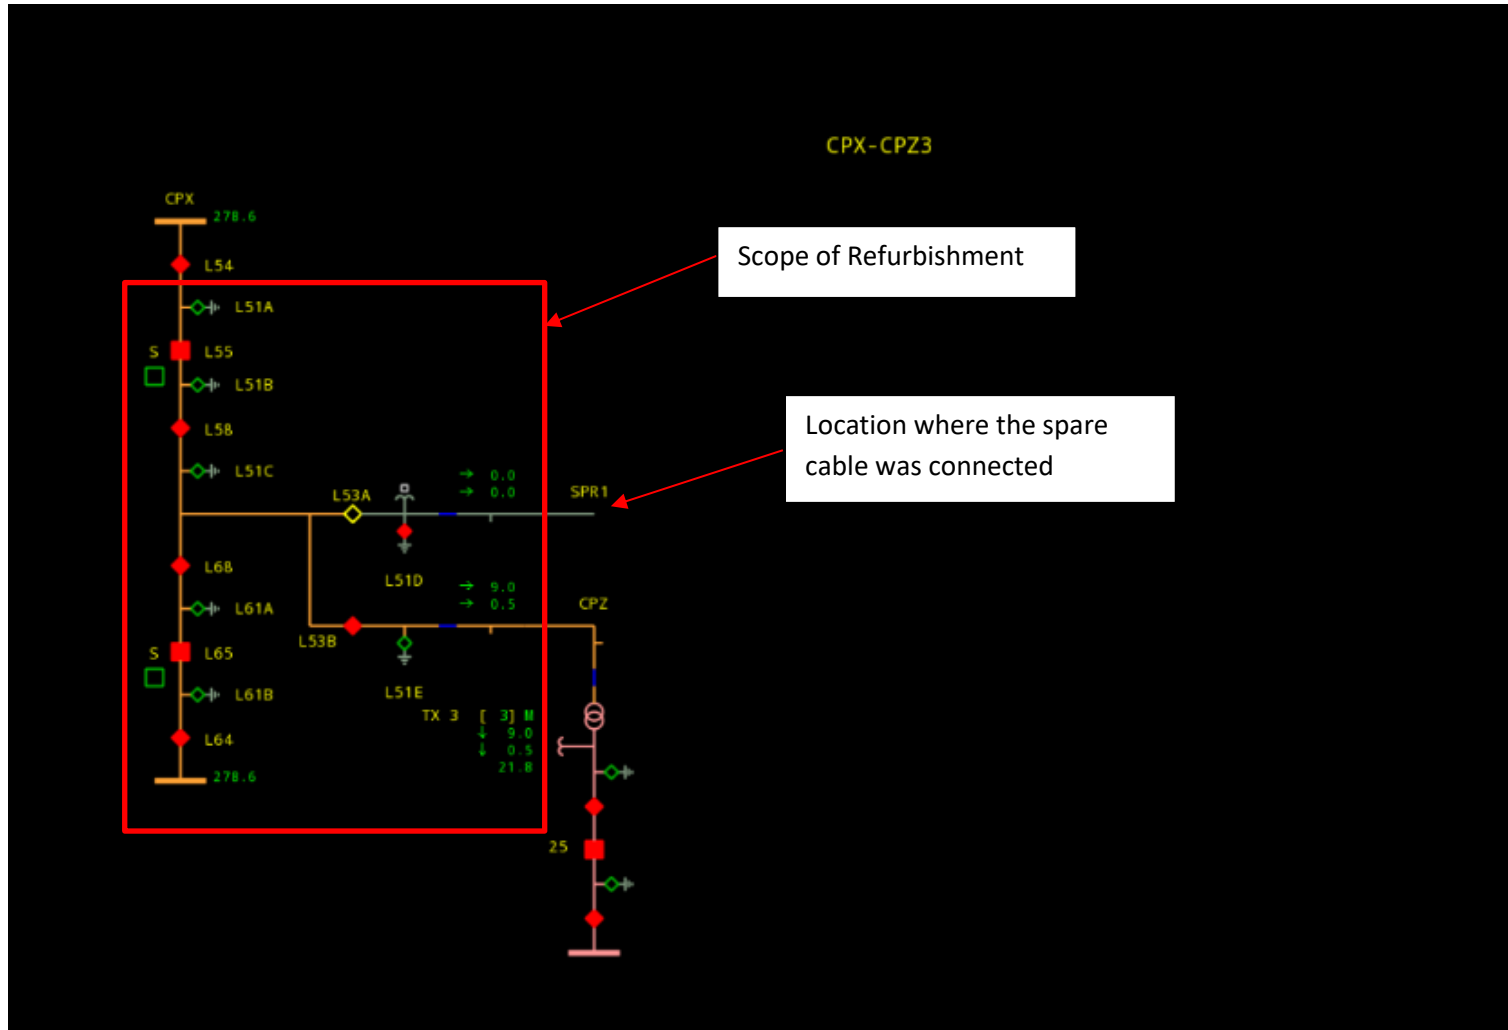
Figure 2. Scope of Refurbishment Work and EMS Circuit Diagram

- 4.3.5 In preparation for the refurbishment work, the engineer in charge performed a number of tasks, including among other things, 1) referred to the EMS circuit diagrams which was a customary practice for using it as reference by engineers to prepare the HV Permit-to-work (PTW); 2) confirmed the circuits connected to the GIS by checking on-site various labels on the GIS; and 3) visually checked external condition of the cable connection
