**Incident of a 275-kV Fault in HK Electric's Power System  
on 19 April 2023**

**INCIDENT INVESTIGATION REPORT**

Date: 15 May 2023

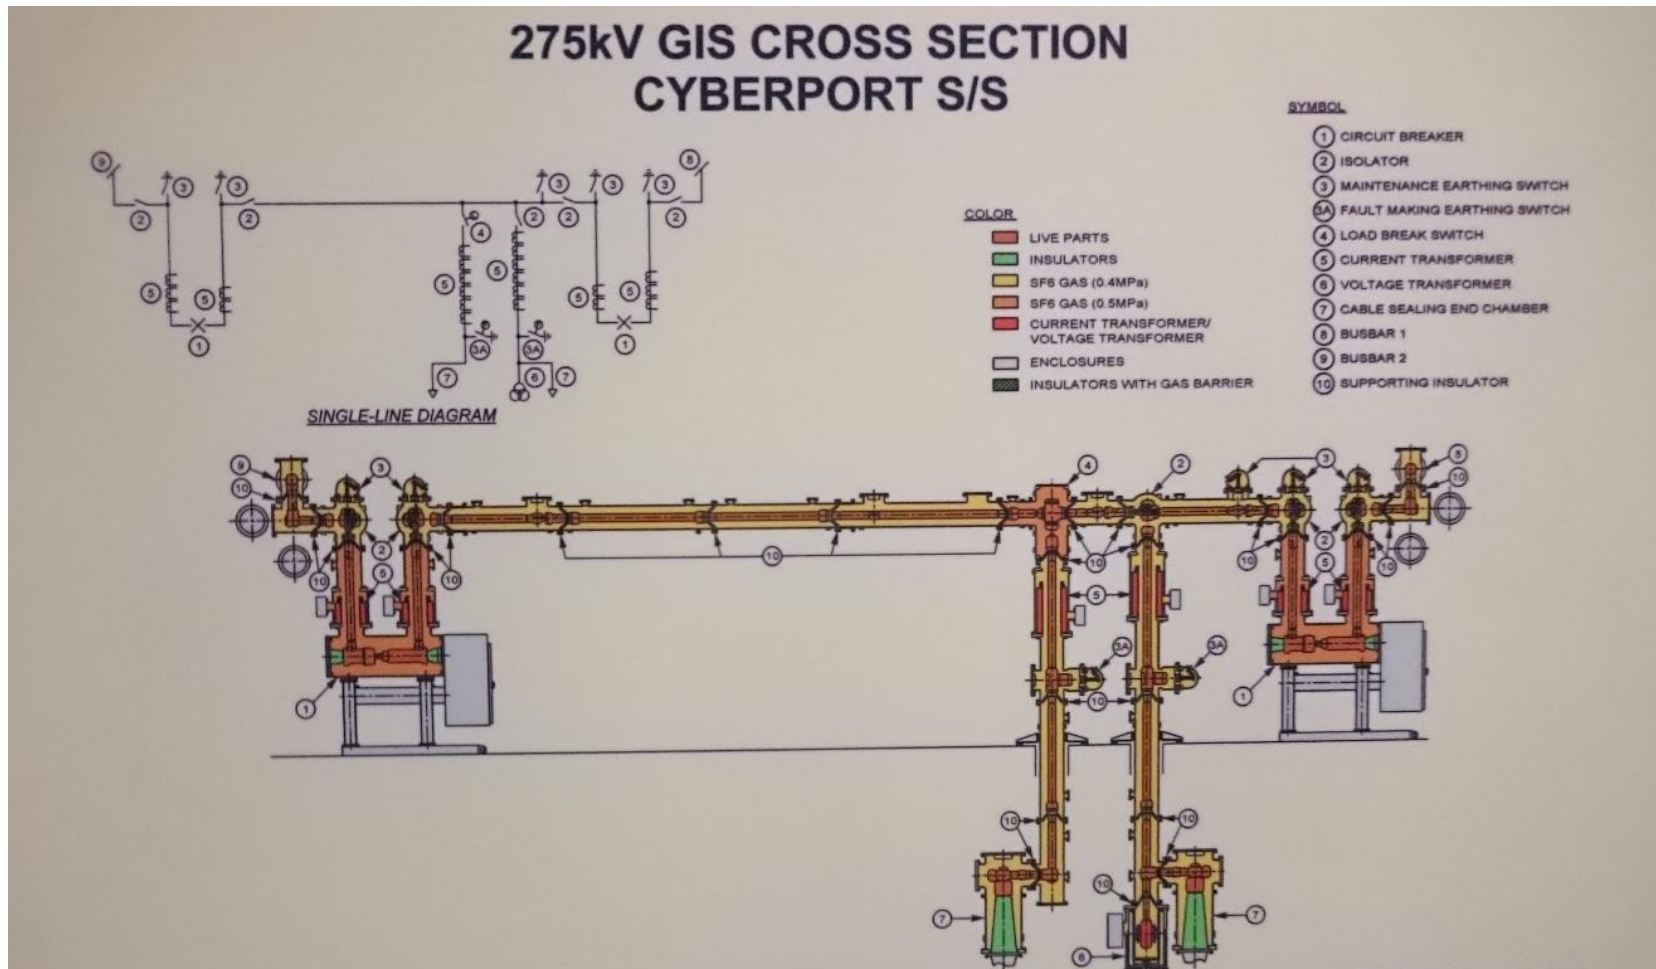
Figure 1. Cross section of CPX 275-kV Gas Insulated Switchgear (GIS)

- 1.8 At the time of the incident, the 275-kV Gas Insulated Switchgear (GIS) of CPX was under commissioning after completion of the refurbishment of one of the switchgear sections as shown in Figures 1 and 2 of Appendix 2. This section of switchgear is connected to one of the two spare cable circuits (mentioned in 1.7) through a cable isolator. As part of the commissioning, all GIS switches that had been worked on, including the cable isolator (named L53A) connected to the spare cable circuit, had to be energised. According to our standard practice, such commissioning work has to be carried out at mid-night and only one in-service circuit is arranged to supply electricity for the commissioning as an additional precautionary measure in order to minimise possible impacts on both the system and our customers if something unforeseeable happened.

- 2.2.2 The GIS installed at CPX was supplied and installed by the original equipment manufacturer (OEM) in 2002, and was designed and manufactured according to international standards. Cross sectional drawing of the GIS involved in this incident is shown in Figure 1 of Appendix 2.
